Water Penetration Through Masonry Walls Field Investigation

Duncan Dining Center
Texas A&M University

This Case Study investigates the Owner's concerns with water entering though the exterior brick veneer two years after the completion of construction.

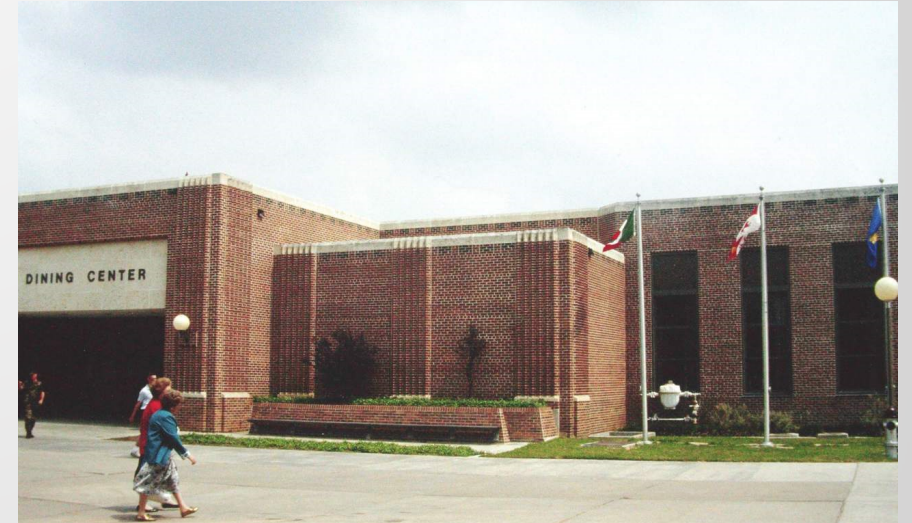
- In the Fall of 1990, reports were received by The Texas A&M University Physical Plant regarding water entering from the new addition's roof through the parapet expansion joints.

Figure 1 – New Entry Canopy Circa 1988

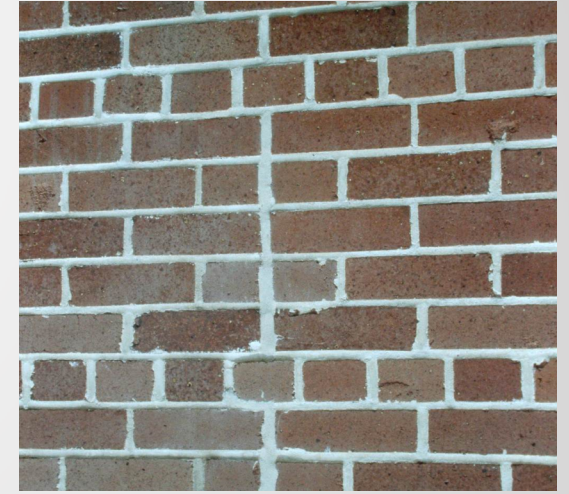
- The building opened for occupancy in the Fall of 1988. The addition's façade is comprised of tumble bricks with tooled concave joints of widths varying from 3/8" to 3/4", presenting an aged appearance simulating the existing building's masonry walls, Figure 2.
- The expansion joints between the existing building and the addition do not satisfactorily seal the construction joint and fail under water pressure.
- Various areas of the building's facade displayed staining and efflorescence as evidence of water entering and exiting the brick veneer cladding Figure 3.

Figure 2 – Simulated older veneer.

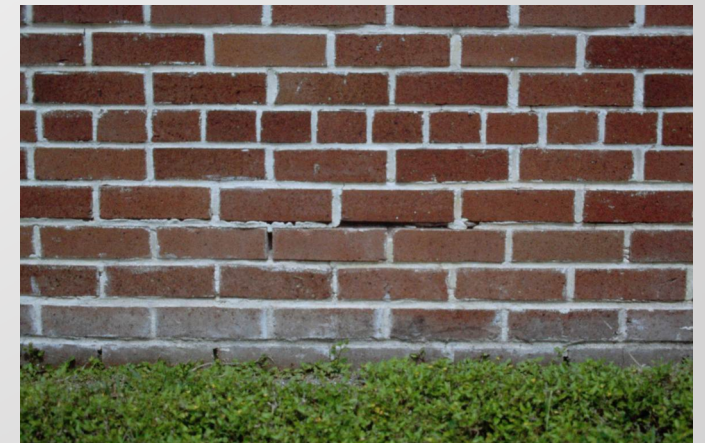
Figure 3 – Efflorescence at the lower portion of the wall.

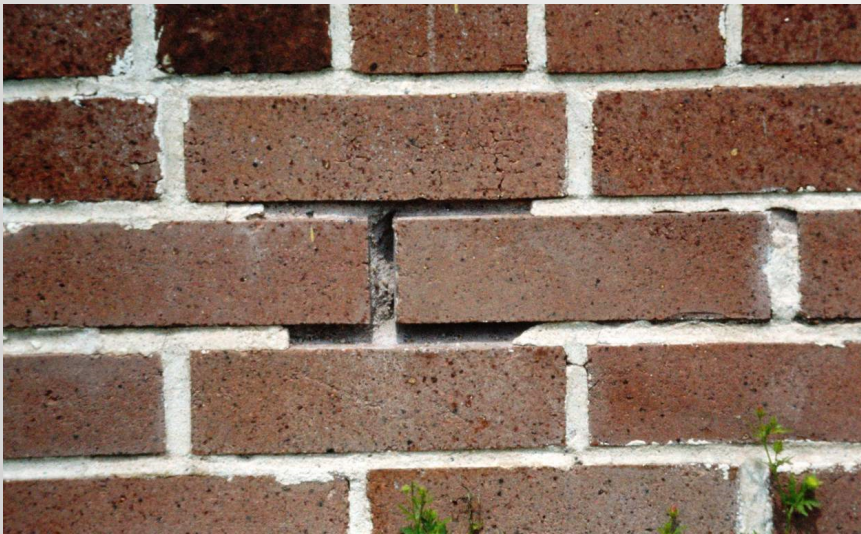
Figure 4 – Mortar voids in new wall.

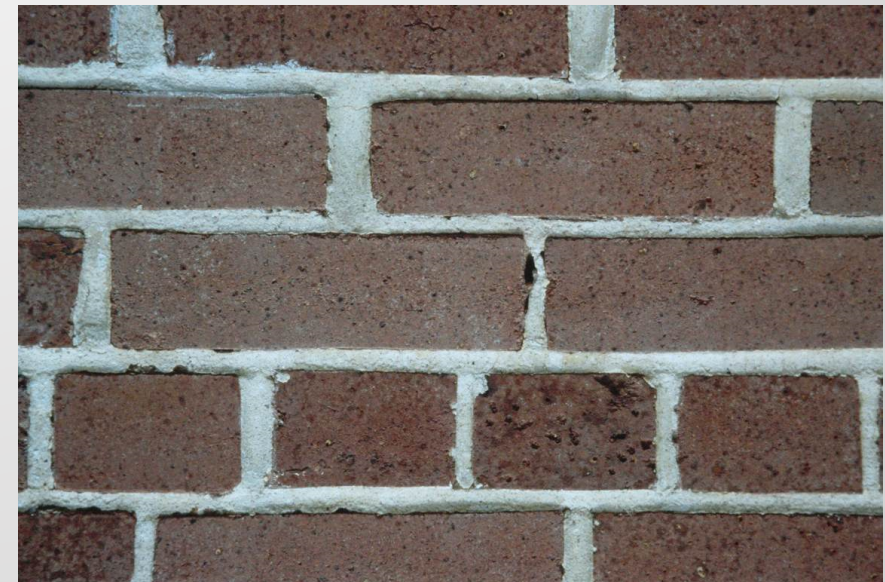
Figure 5 – Un-tooled joints in new wall.

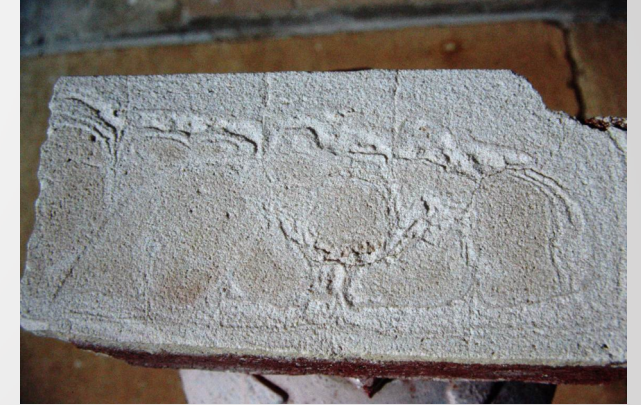
- Second Step - Remove brick prisms and observe the workmanship of the assembly's construction.
 - ❖ The brick used, a modular brick with dimensions of 2-5/8"H x 3-5/8"W x 7 5/8"L.
 - ❖ The average prism, two (2) bricks long and four (4) brick tall is about sixteen inches (16")L x twelve inches (12")H.
 - ❖ The mortar used is of a sand-lime proportion to match the original blend.
 - ❖ Initial observation indicates poor workmanship and execution. The bricks appear to have been reset (moved or adjusted) after initially set in the bed course.[4,5]

Figure 6 – Top of removed brick with mortar – typical.

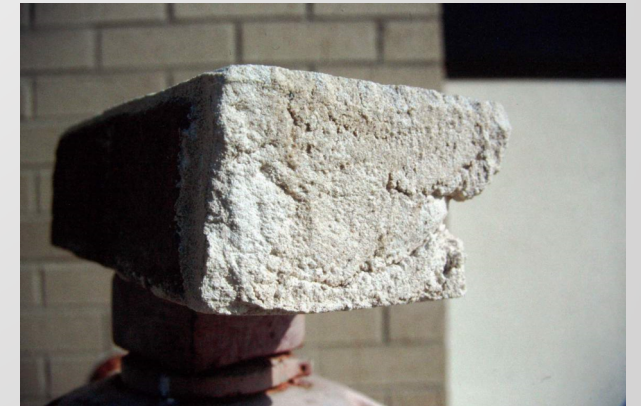
Figure 7 – Head joint of removed brick – typical.

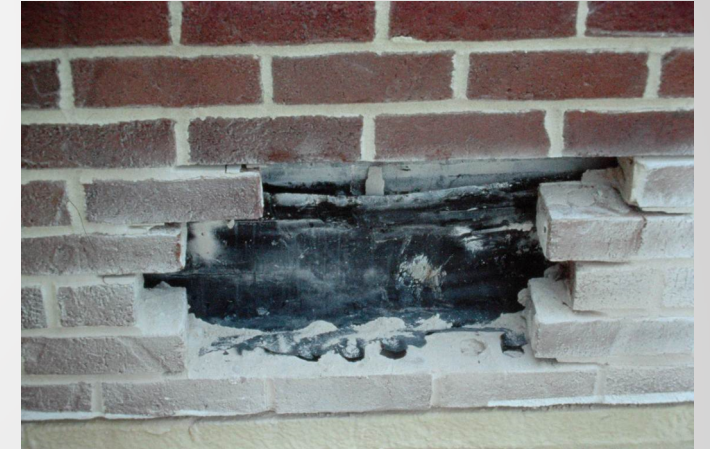
Figure 8 – Opening in the parapet wall

- ❖ Investigations of the flashing system indicated that the counter flashing assembly incorrectly installed, Figures 8 and 9, and on the east side of the entry, the weep holes omitted.

- Wall Cavity - Figures 8, 9, 12, and 13.
The polyethylene moisture barrier is haphazardly installed, loose, and reasonably ineffective.
 - ❖ The arrow points to an overlap of the barrier behind which the upper leg of the flashing is concealed. However the poly-flashing deteriorated by the lime in the mortar is non-existent.
 - ❖ The limp poly-flashing has not sufficient integrity to contain and divert water from the interior wall cavity and into the building.
- Wall Cavity - Figure 13
 - ❖ The yellow area at the bottom of the picture is the urethane foam roof coating. During intense rain storms, gathering water rises up the sides and into the building.
 - ❖ The wall cavity also contains sufficient mortar to restrict the water entering the building.

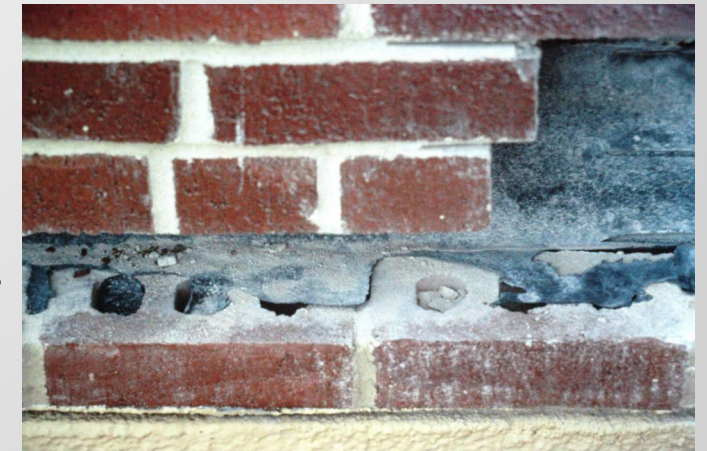
Figure 9 – Opening in the parapet wall

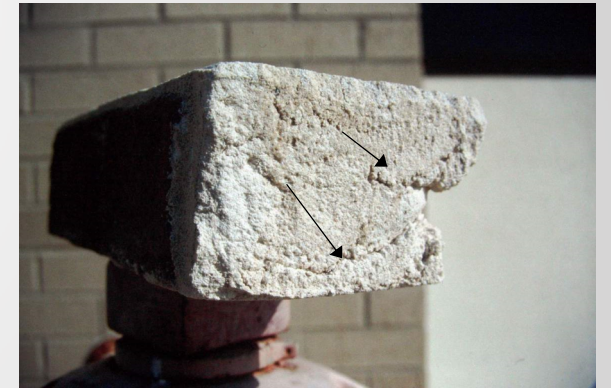
- Figure 10 shows a head joint cut from a portion of the wall of the new building. The brick, removed without resistance, indicates the lack of bond with the mortar. Such would be caused either by the brick's high IRA value and the mortar's low quality.[5]

- ❖ The depressions on the mortar's surface indicate that the brick was either moved from its initial position and (possibly) additional mortar added to the joint or the mason did not use proper bricklaying technique by exerting adequate pressure to yield a tight head joint.

Figure 10 – Head joints

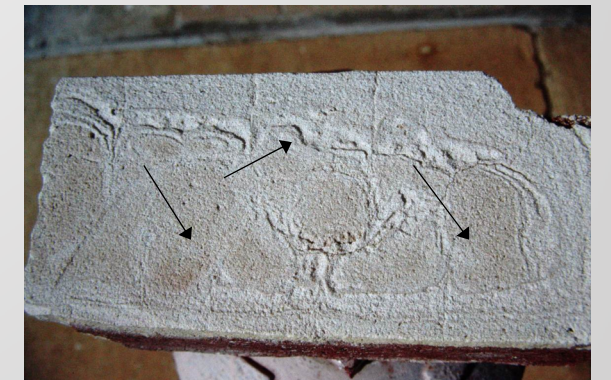
- Figure 11 shows a bed joint extracted from another location in the same wall, indicating the same deficiencies as in the previous head joint. In a few other joints, the mortar was so deficient in quality that it powdered when rubbed with fingers.

Figure 11 – Back of typical prism

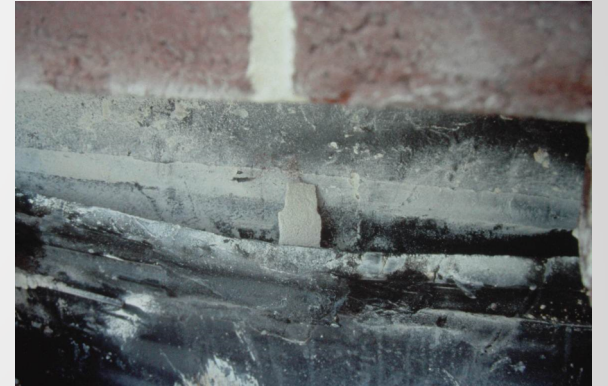
Figure 12 – Wall cavity

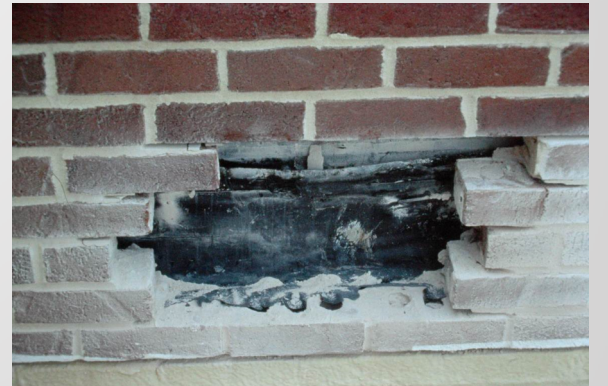
Figure 13 – Wall cavity
