MASONRY TECHNOLOGY AS A CONTRIBUTOR TO AFFORDABLE CONSTRUCTION IN THIRD WORLD COUNTRIES

Tom Hines¹

1. Principal - Tom Hines, Architect - Denton, Texas 76208.
Original paper presented May 05, 1994, in a series to the School of Architecture at Texas A&M University

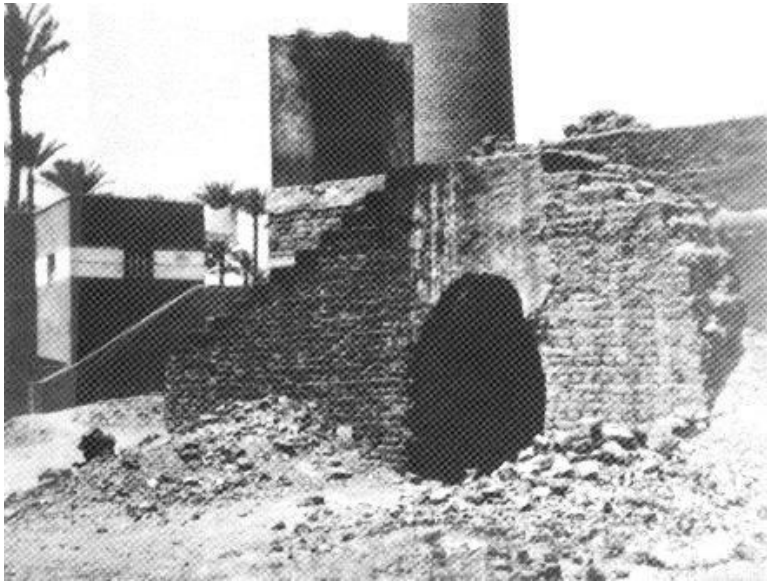
Figure 1 - Brick work detail in the old Cairo quarters on an old but operational brick kiln.

Throughout the history of man, one of the most formidable staples in his palette of construction materials is masonry - in many forms, types, and shapes. The use of brick as a building material dates back over 5000 years, [13]. Some of the oldest and most beautiful examples of brick architecture are found in the regions of the Tigris-Euphrates Nile Valleys. The sun-dried bricks, used by the early Egyptians to build their dwellings, came from the alluvial clays of the Nile Valley, (Figure 1).

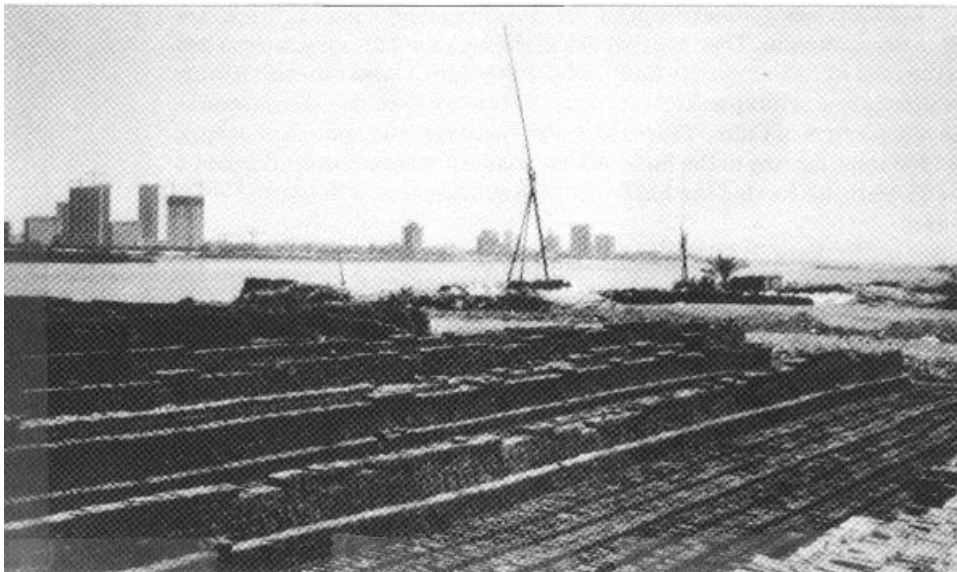
Figure 2 - Present day brick manufacturing in Egypt. Sun drying of bricks before going through the kiln. Little has changed in this process from ancient to present day Egypt.

In these areas, having an abundance of clay deposits and being scarce in wood and stone, people first learned to use the clay to make bricks, (Figure 2). With the advent of copper in the use of making tools by 4000 B.C., the Egyptians were able to perfect sophisticated materials and construction methods thus accelerating their technology, (Figure 3).

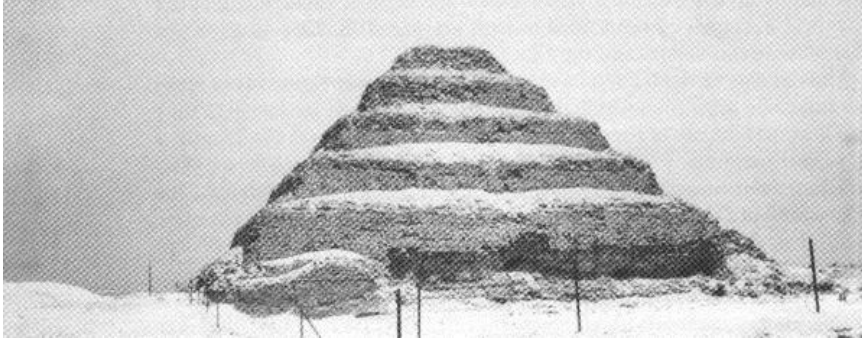
Figure 5 - Pyramid at Memphis, Egypt. The forerunner of the later Cheops pyramid. Circa 2650 BC.

Development of this technology led to construction projects such as the Ziggurat at Ur, (Figure 4), and the pyramid near the city of Memphis, the first capital of Egypt, (Figure 5), the forerunners of the later large Cheops pyramid. Built of sandstone and brick, these pyramids were constructed in terraced steps. Evidence has revealed that stone was used in early Egyptian buildings; however the primary staple for all types of structures was brick. The use of masonry has continued through the centuries to modern times, [1].

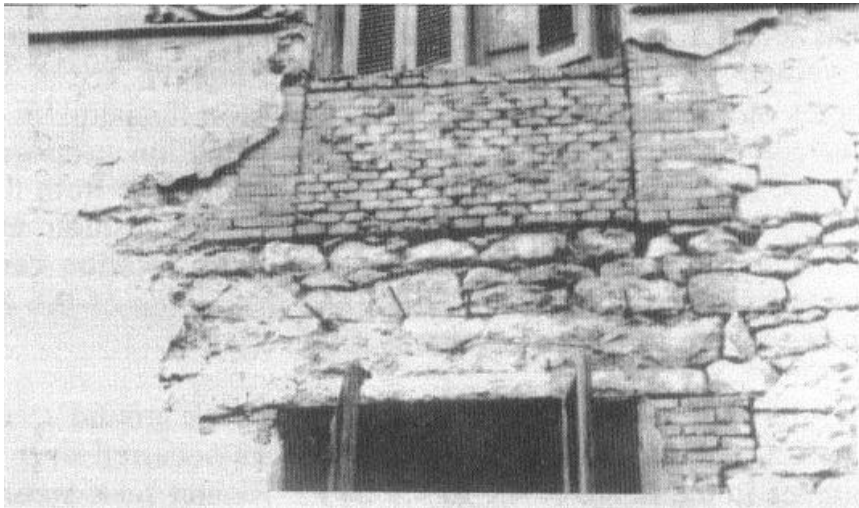
Figure 6 - Use of stone and brick masonry around window openings.

Additionally, unburned clay bricks are used to provide flexibility around windows. Sometimes plastering (rendering) was used to cover the masonry and over time has suffered cracking and spalling thus exposing the soft masonry to weather conditions. The exposure weakens the wall system by deterioration, in many one-story residential buildings, shale clay and mud clay were used as the main building products, [2].

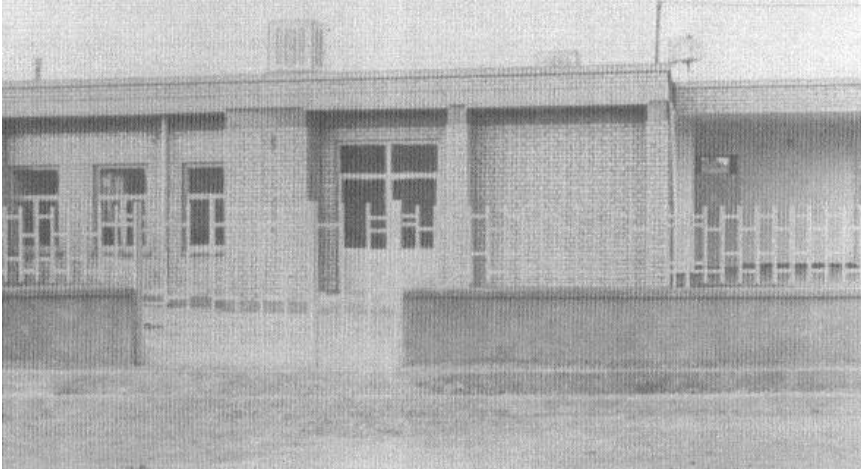
Figure 16 - Engineered reinforced masonry building that survived the Sirch earthquake of July 28, 1981.

Engineered reinforced brick buildings in Sirch survived better than unreinforced masonry buildings after the trembler of July 28, 1981. The structure was made with steel tie beams and I-cross sections at the top of the external walls and the reinforced concrete vertical elements at some corners. One particular building was in the epicentral region of the earthquake and survived the strong ground motions with moderate structural damage and heavy partition damage. The bond between the steel tie beams and the brick walls failed.

Newly engineered reinforced brick buildings build with proper reinforcement, withstood the Sirch July 28, 1981 earthquake shaking with minimal damage, if any at all. These buildings used good quality extruded, kiln-fired bricks, sand-cement mortar, and concrete tie beams at the top of all walls (Figure 16). Resulting from the engineering, the buildings behaved like a monolithic box structure. In the town of Golbaf which was devastated by the shock of June 11, 1981 (killing 1 200 people out of a population of 13,000), the only residential building without any structural damage was reinforced with horizontal and vertical concrete elements as mentioned above.

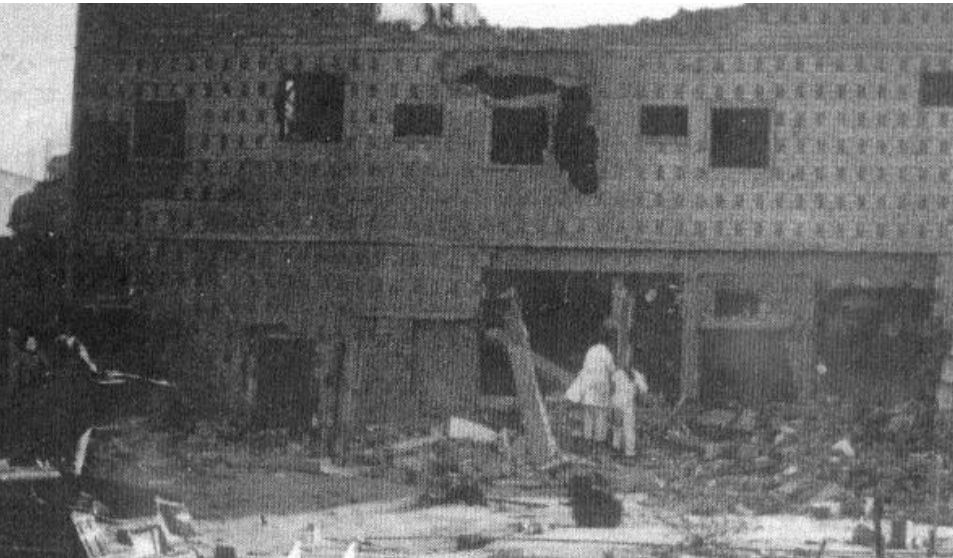
Figure 19 - Building with a RC frame, with infill masonry walls, subjected to shelling.

- Reinforced Concrete Skeleton with infill Walls fared exceptionally well against shelling and fire. The concrete frame and the diaphragm strength of the floors absorbed the shock and kept the buildings from collapse.

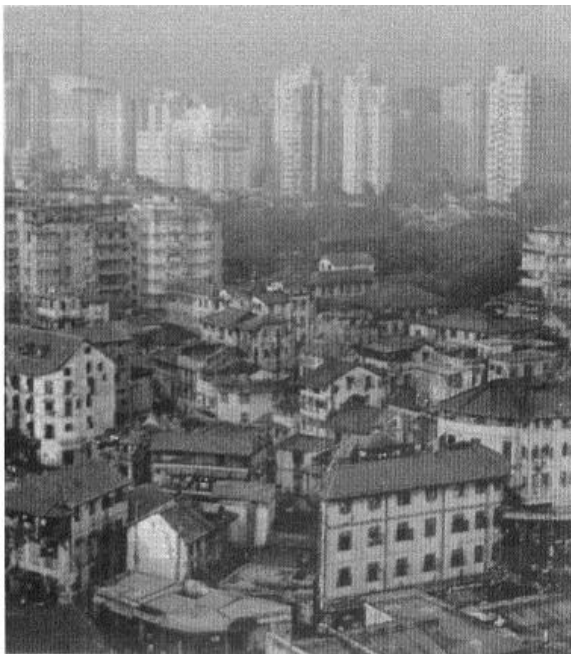
Figure 25 - High-rise masonry and concrete structures and slum areas at the edge of downtown Bombay.

Figures 25 relates the type of masonry construction projects typical of events over the past 12 years. In this urban center, slum clearing is a typical event for housing projects. The units for this building were hand-molded bricks of medium strength first storey and then the cheaper units of uncertain strength finished out the building.

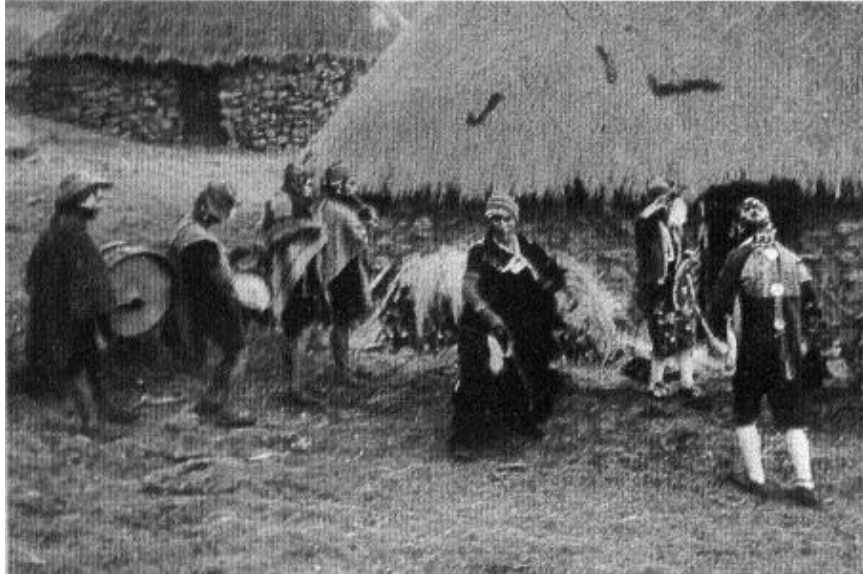
Figure 29 - Typical hut construction of adobe and stone walls and floor with a roof of straw.

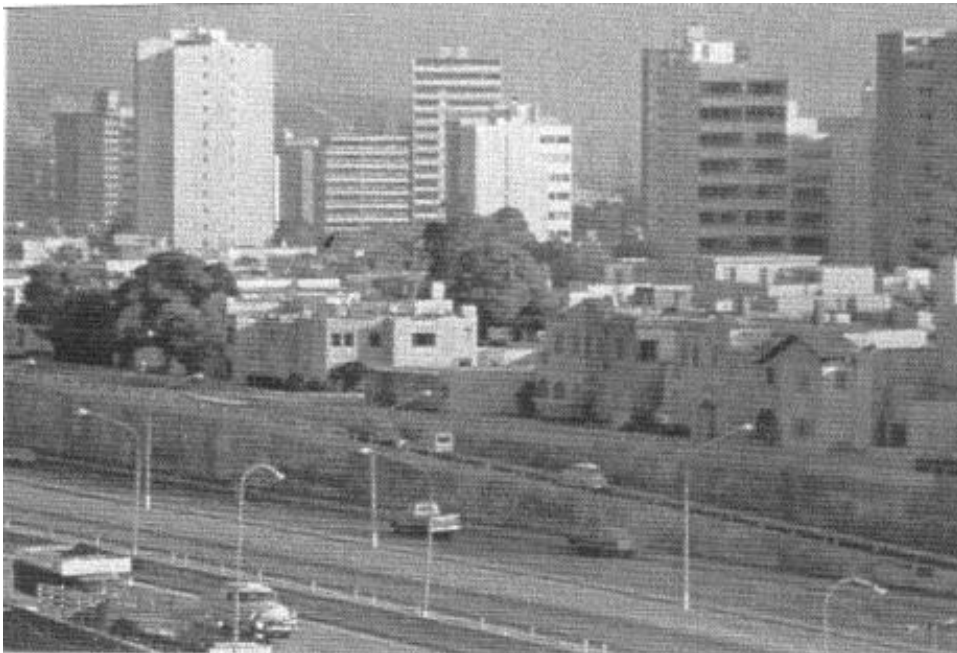
Figure 31 - Reinforced concrete and masonry high-rise construction in Lima. Low-rise reinforced masonry housing units in the foreground.

Today all three practices are used throughout the country. In the capitol city of Lima, many high-rise buildings have been constructed since 1979, (Figure 31). The two practices of reinforced engineered masonry construction are infill panel and confined design, [14], (Figure 32). The government of Peru is working very hard to eliminate the development of squatter settlements around the urban areas, [14]. Most of the houses built on squatter land are of adobe and some plain masonry, [14]. These areas, now called new towns by the government, are at best susceptible to the worst type of damage that could result from seismic activity, [13,14].
